Manhole Inspection Summary

Manhole # S49K__017MH

Insp Date: **2/10/09 2:19 PM**

Location Address: **700 FOSTER-FAIT-ALLEY**

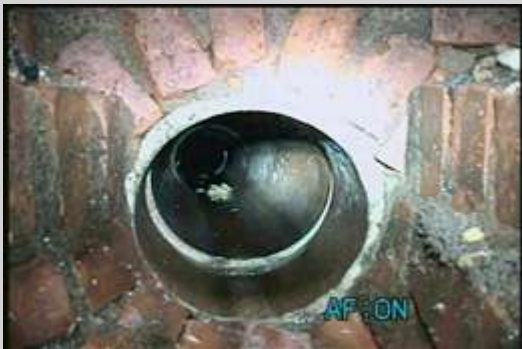
3 O'Clock Inflow

8 in. Circular Gravity Sewer
Pipe In @ 3 Oclock

Pipe Height: **8.4** (in.) Rod and Bar (Angled)
Pipe Material: **Clay** ☐ Pipe Lined
Invert Depth: **8.89** (ft.) Flow Characteristics: **Slow**
Deposits: ☒ **None** ☐ Mud ☐ Sludge ☐ Debris ☐ Grease
Silt Depth: **0** (in.) Deposits Extent:
Infiltration: **None** Pipe Seal Cond: **Sound**

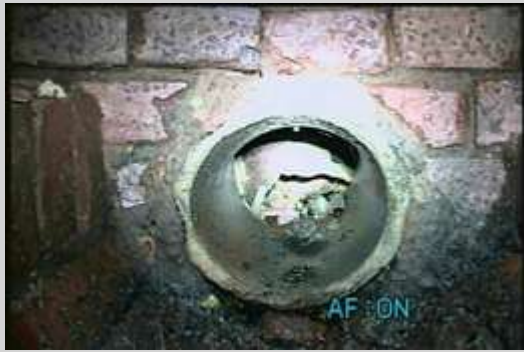
6 O'Clock Inflow

6 in. Circular Gravity Sewer
Pipe In @ 6 Oclock

Pipe Height: **6** (in.) Rod and Bar (Angled)
Pipe Material: **Clay** ☐ Pipe Lined
Invert Depth: **8.79** (ft.) Flow Characteristics: **Slow**
Deposits: ☒ None ☐ Mud ☐ Sludge ☐ Debris ☐ Grease
Silt Depth: **0** (in.) Deposits Extent:
Infiltration: **None** Pipe Seal Cond: **Sound**

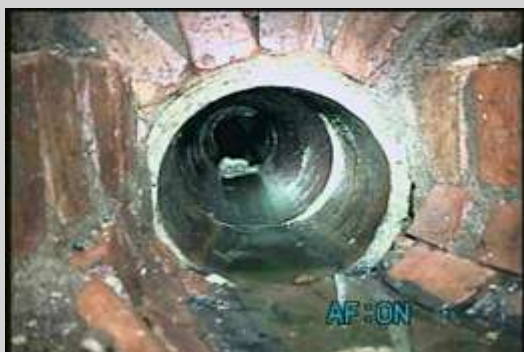
9 O'Clock Inflow

8 in. Circular Gravity Sewer
Pipe In @ 9 Oclock

Pipe Height: **8.4** (in.) Rod and Bar (Angled)
Pipe Material: **Clay** ☐ Pipe Lined
Invert Depth: **8.87** (ft.) Flow Characteristics: **Slow**
Deposits: ☒ None ☐ Mud ☐ Sludge ☐ Debris ☐ Grease
Silt Depth: **0** (in.) Deposits Extent:
Infiltration: **None** Pipe Seal Cond: **Sound**
